Former West Belconnen Fire Station
UPSS Validation Report – Former West Belconnen Fire Station, Belconnen, ACT
Commercial-in-Confidence

**Subject to Legal and Professional Privilege
 Waste Classification Letter - Block 6, Section 97, Charnwood, ACT**

Charnwood Phase 2 Environmental Site Assessment Report
Phase 2 ESA Sampling Locations

PHOTOGRAPHIC LOG			
Site Name: Former West Belconnen Fire Station		Site Location: 35 Lhotsky Street, Belconnen, ACT	Project No: 60339175
Plate No. 1	Date: 4/2/2015

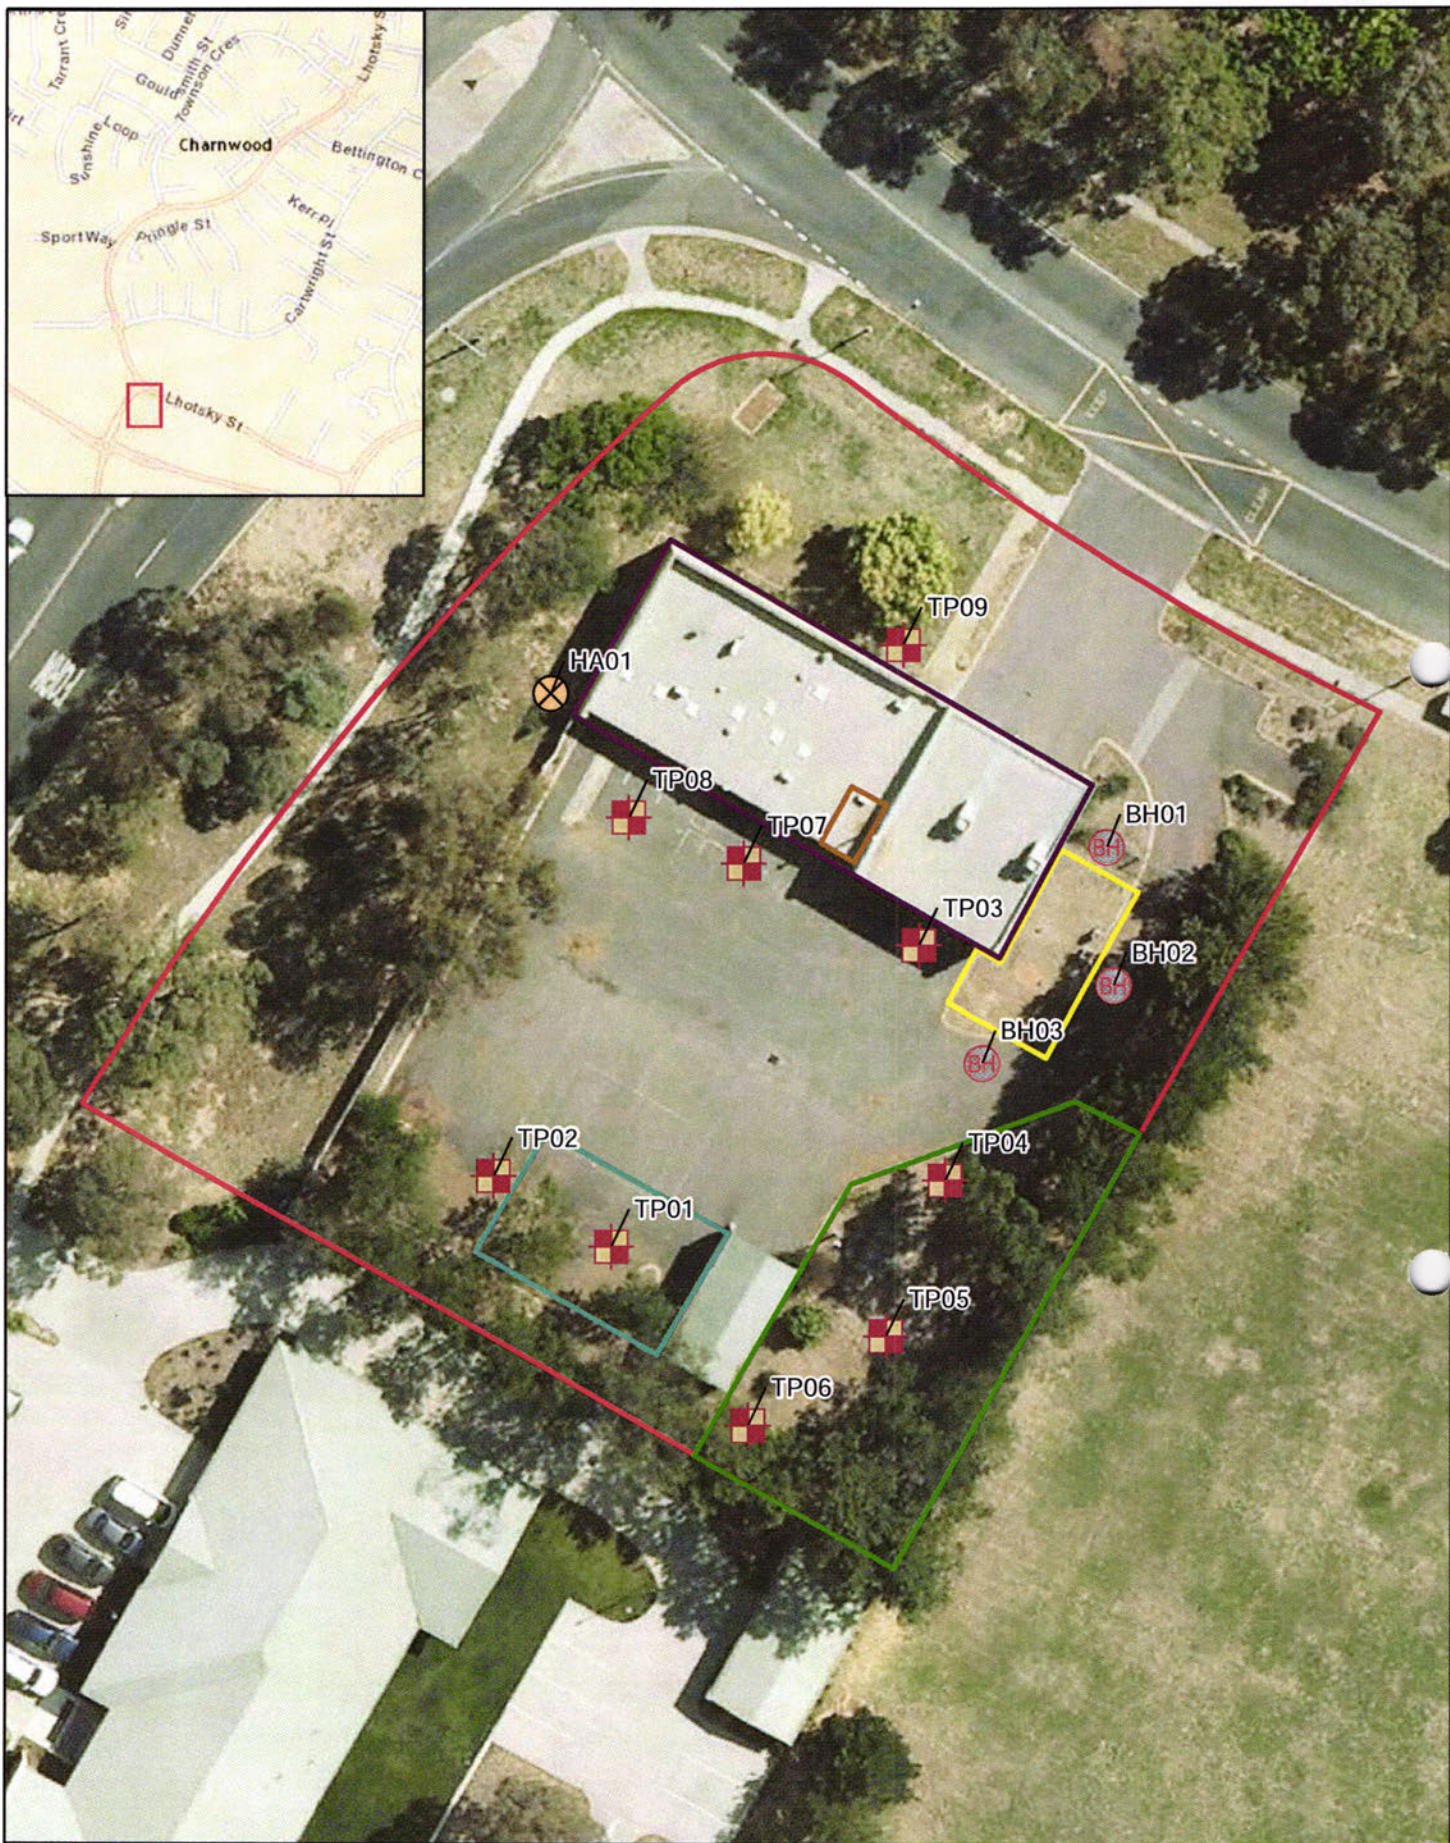
Fig. 2

- Site Location
- AEC 01 - Former USTs
- AEC 02 - Car wrecks/training
- AEC 03 - AFFF storage
- AEC 04 - Potential uncontrolled fill
- AEC 05 - Septic tanks and drainage (assumed)
- Borehole
- Hand Auger
- Test Pit

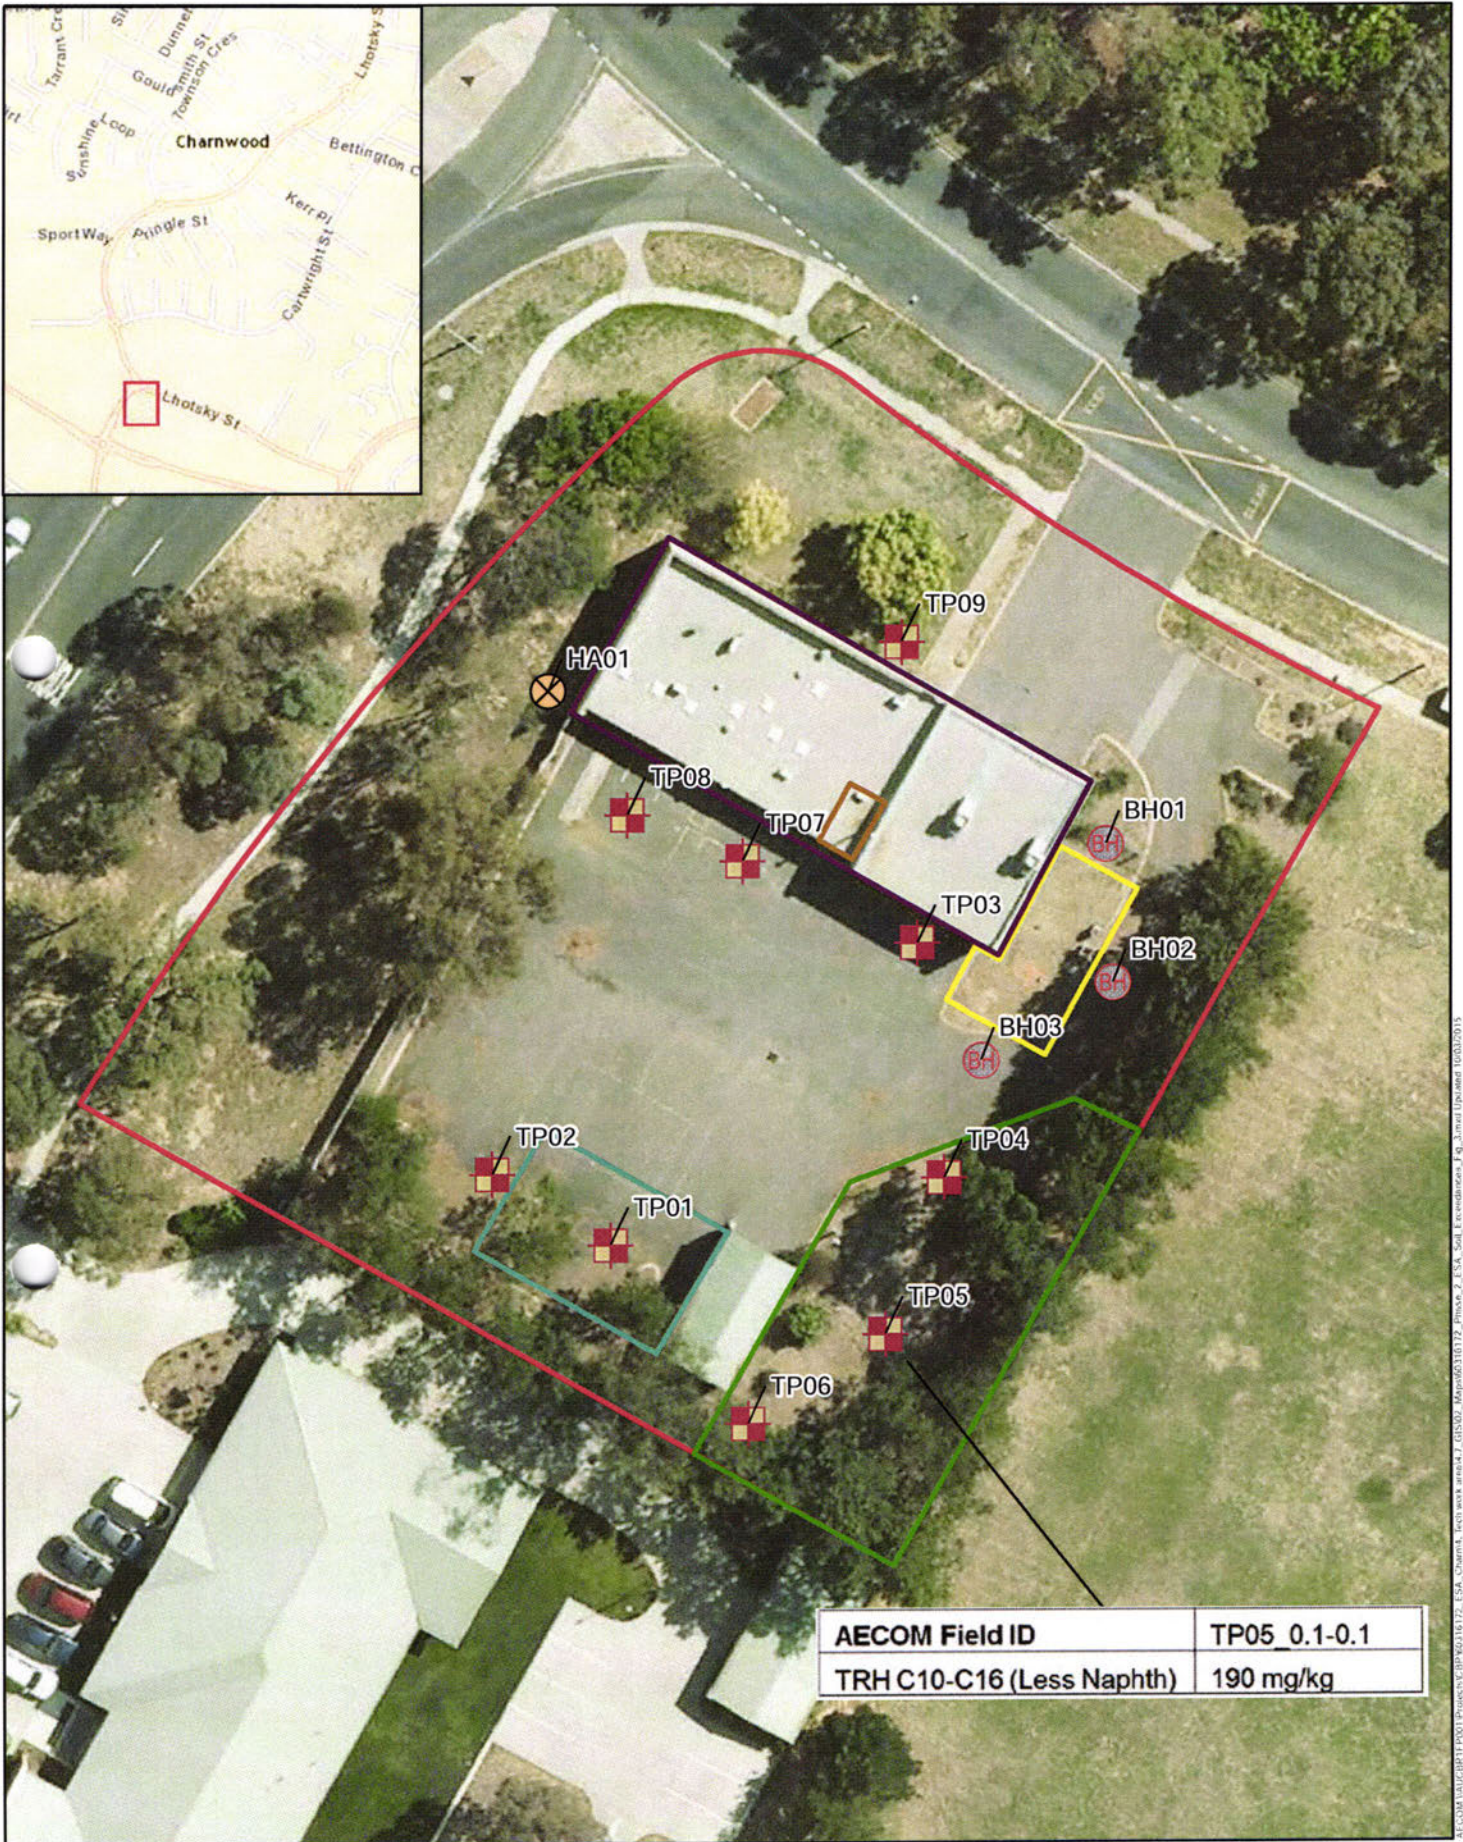
AECOM Field ID	TP05_0.1-0.1
TRH C10-C16 (Less Naphth)	190 mg/kg

- Site Location
- AEC 01 - Former USTs
- AEC 02 - Car wrecks/training
- AEC 03 - AFFF storage
- AEC 04 - Potential uncontrolled fill
- AEC 05 - Septic tanks and drainage (assumed)
- Borehole
- Hand Auger
- Test Pit

Remedial action via targeted removal and validation of the surface soils in AEC01 in the immediate vicinity of sample location TP05 is recommended to address the identified potential exposure pathways (and risk) for the proposed childcare facility development on the Site.

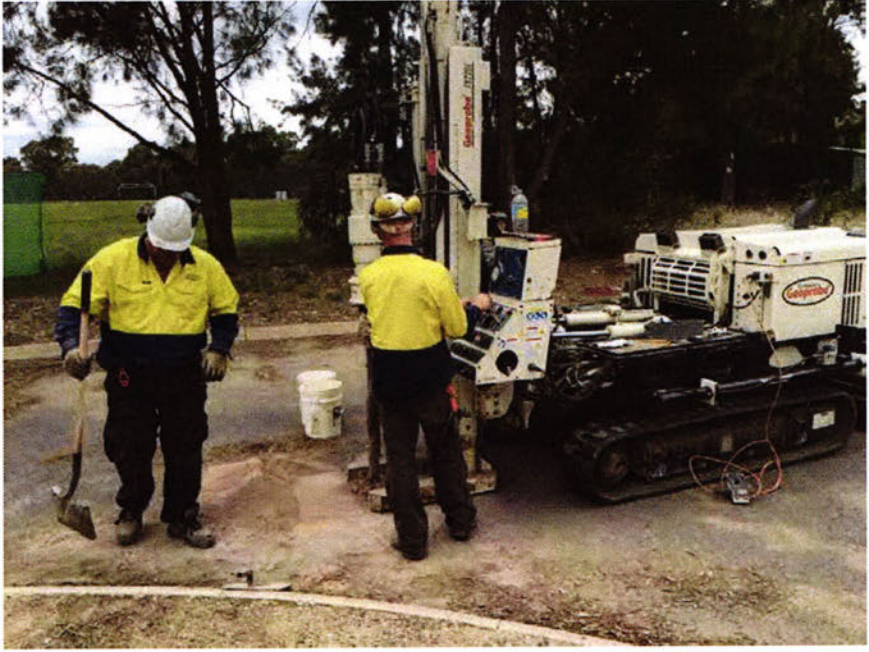
Direction Photo Taken: South-East			
Description: Drill rig at borehole (BH) number 3 in AEC 01 (former UST's). This particular location was immediately adjacent to former underground storage tank (UST) number 1.

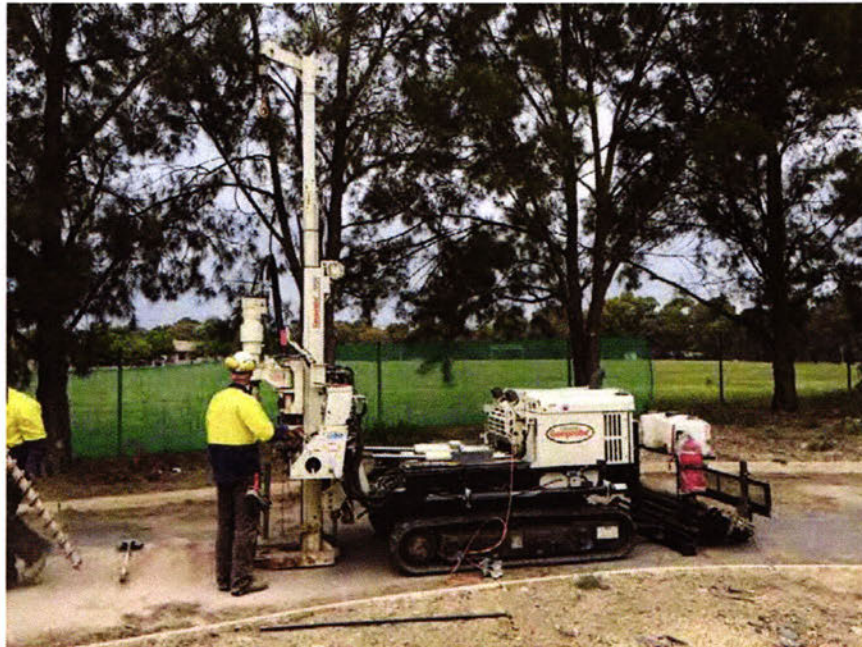
Drill rig at BH02. SFA attachment to be used.

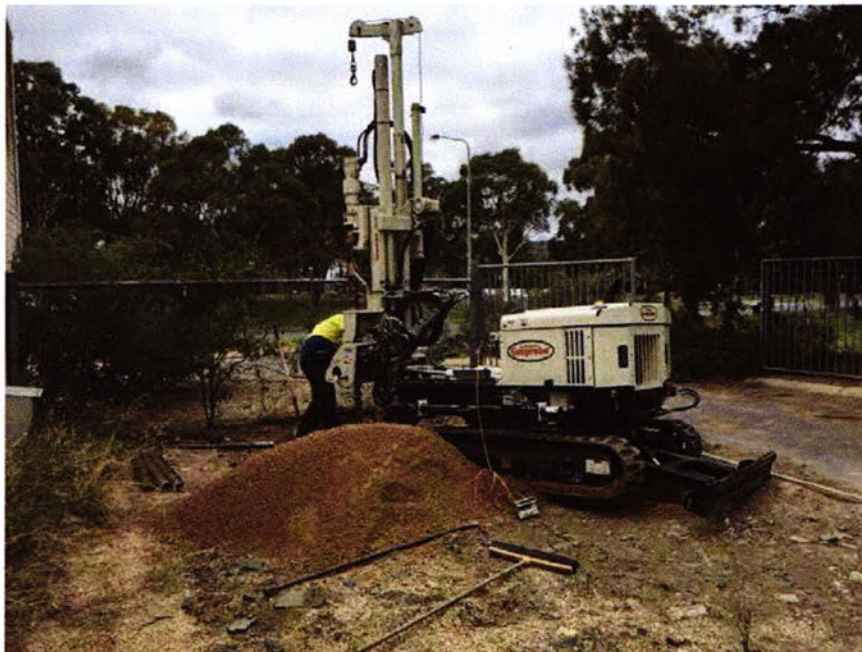
BH01 location adjacent to former UST03.

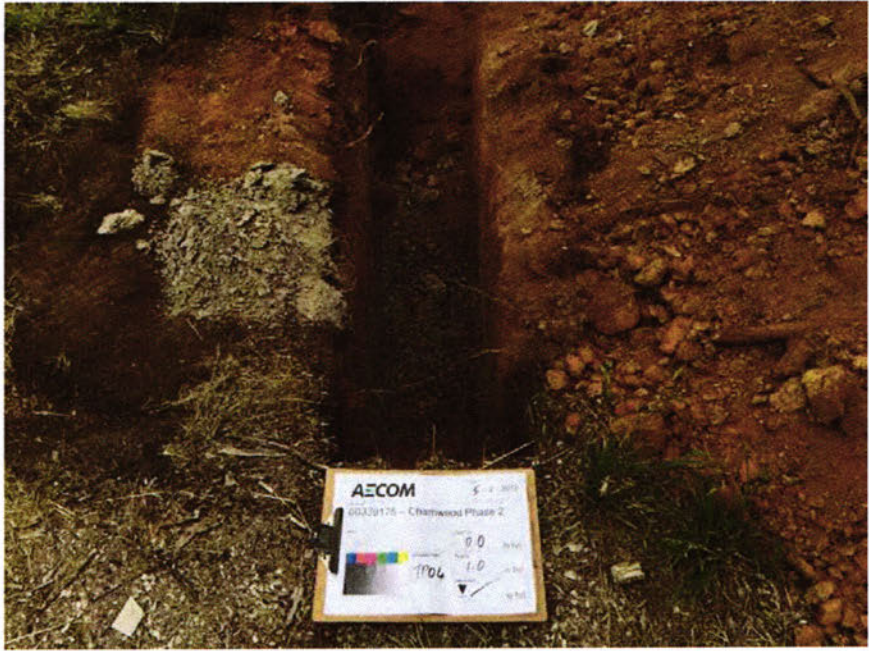
Plate No. 9	Date: 5/2/2015

Direction Photo Taken: N/A		
Description: Tone excavation of TP04 - terminated at 1.0 m bgl following refusal on bedrock.

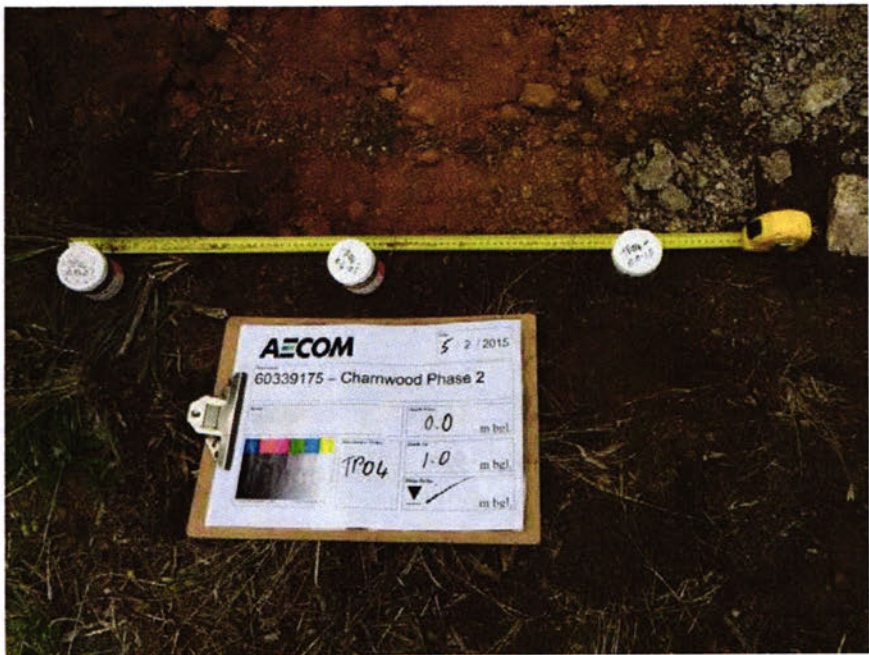
Plate No. 10	Date: 5/2/2015

Direction Photo Taken: N/A		
Description: Soil profile of TP04 which terminated at 1.0 m bgl. Note the topsoil, silty sand, sandy clay and weathered rock encountered.

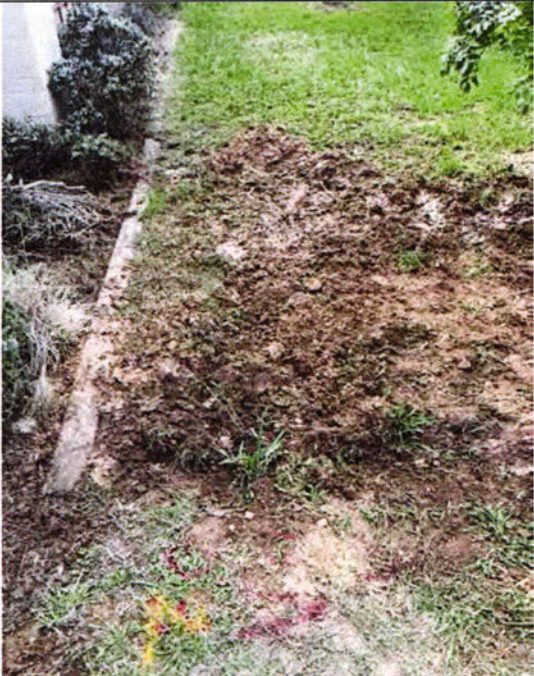
Plate No. 18	Date: 5/2/2015

Direction Photo Taken: North-West		
Description: Water was removed from TP09 via the use of buckets and the hole backfilled. Note the conduit adjacent to the test pit.

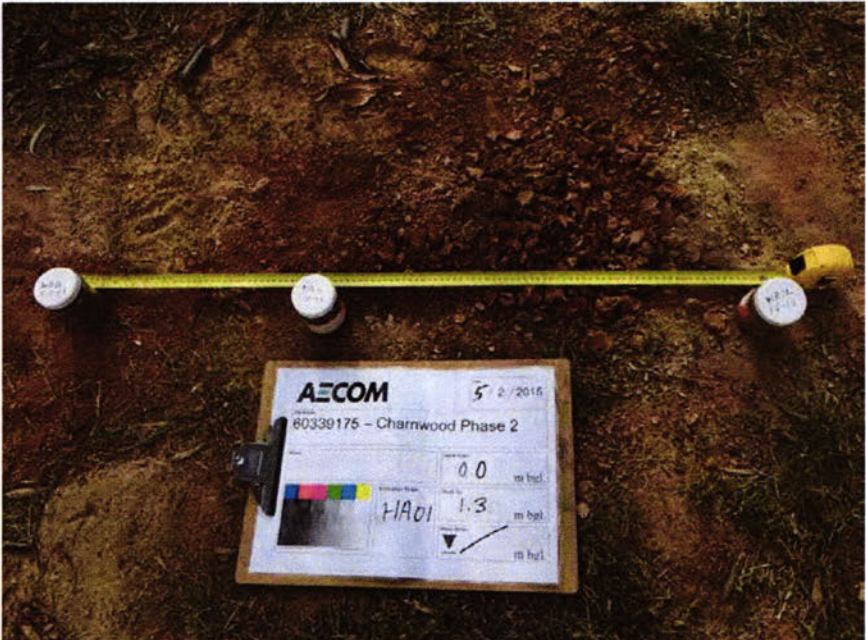
Plate No. 19	Date: 5/2/2015

Direction Photo Taken: N/A		
Description: Soil profile of hand auger (HA) location 1. Note the silty sand, gravelly sand and clay which is characteristic of the entire project area.
